Inspection Report

Company HMP HOME INSPECTIONS

Address 123 MAIN ST.

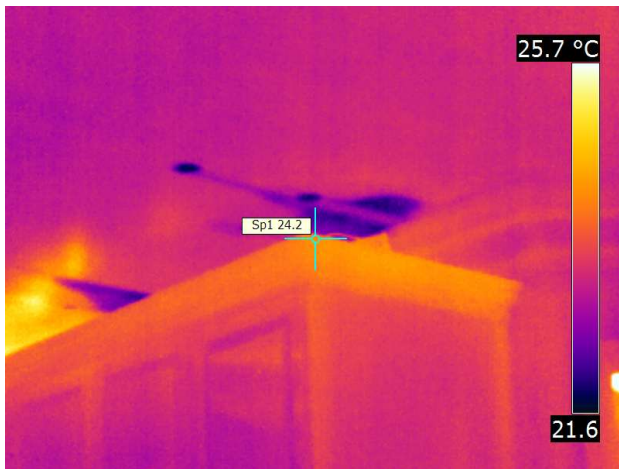
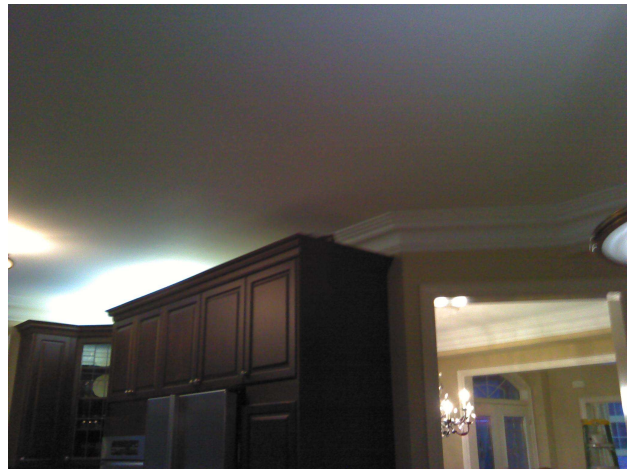
Kitchen ceiling. Evidence of water leaking from upper ensuite bathroom. Darker areas show water pooling on the drywall.

Recommended task is to remove water damaged drywall to investigate suspected void in plumbing. Make necessary repairs.
